WILD TROUT TRUST
wildtrout.org

River Axe, Kingfisher Common near Wookey, Somerset

Advisory Visit July 2024

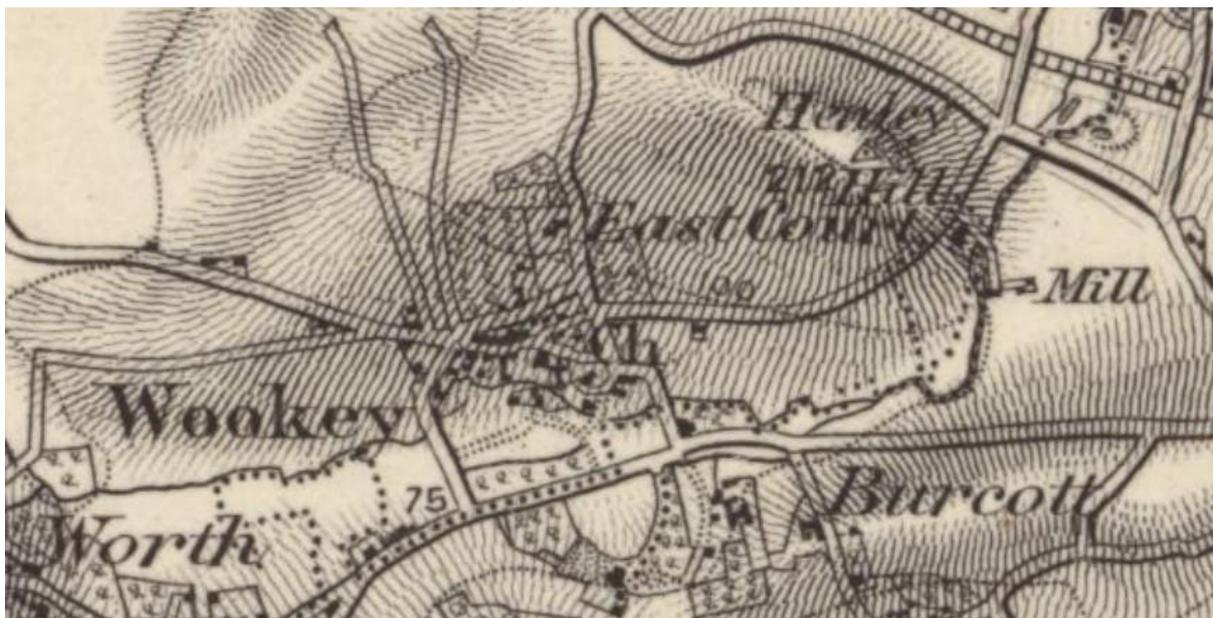
Figure 2: 1892 map showing the River Axe at Kingfisher Common and its surroundings, including Henley Mill. (Reproduced with permission of the National Library of Scotland)

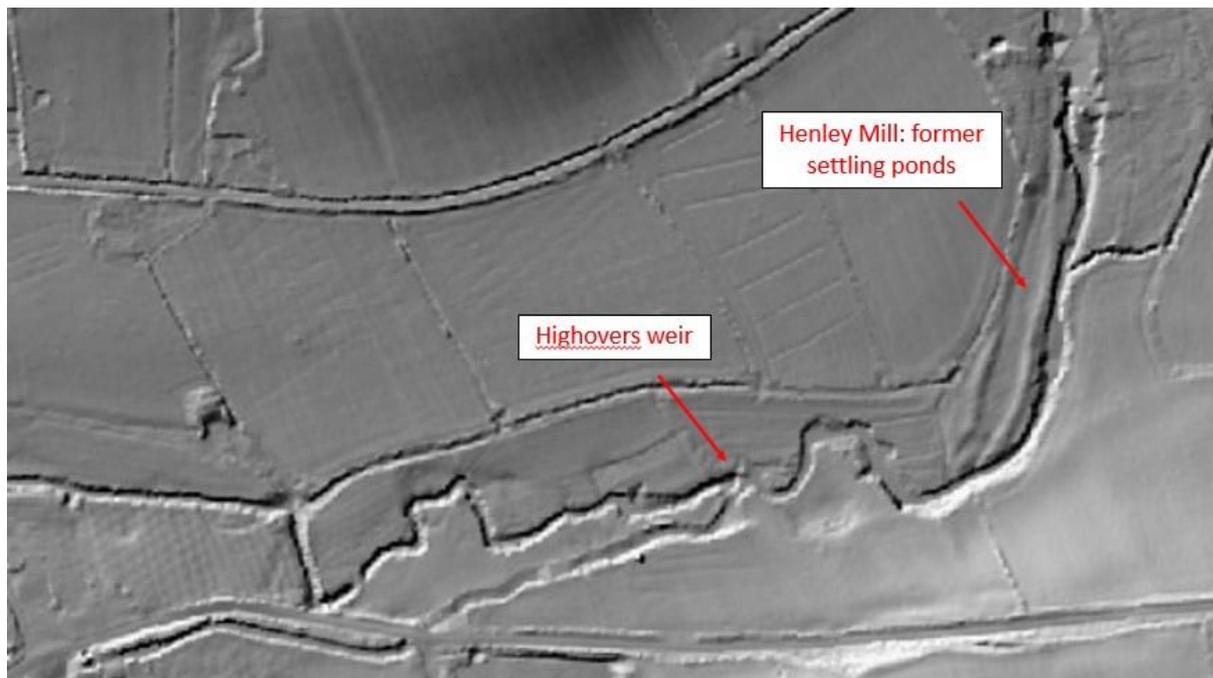
Evidence for earthworks associated with these settling ponds (including a bund along the RB of the river, which is also noticeable on the ground) can be seen from LIDAR surveys of the Kingfisher Common area:

Figure 3: LIDAR survey image of the Kingfisher Common area, showing the extent of earthworks associated with Henley Mill, as well as possible hints of older natural and artificial channel courses

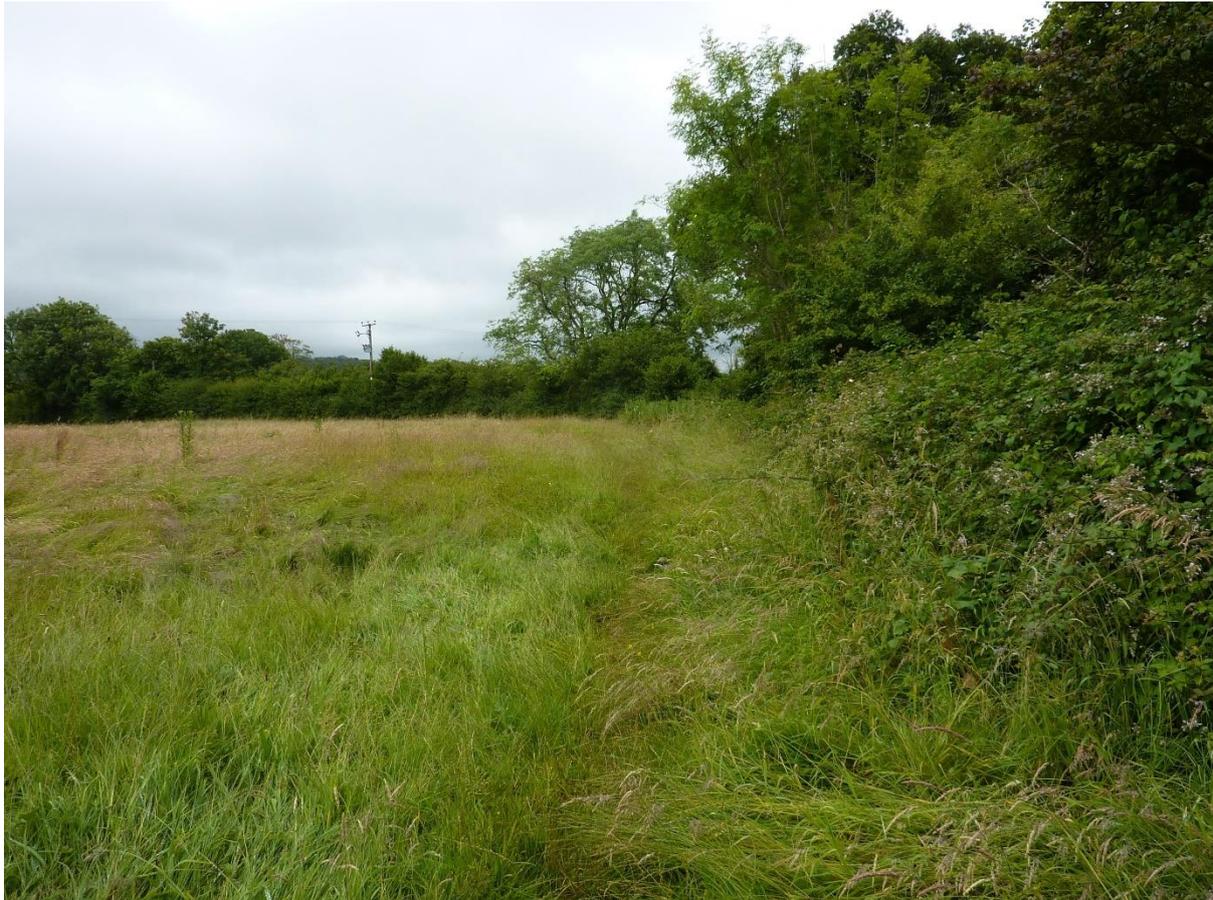
Figure 4: Looking upstream near the gauging weir discussed below: the river is completely hidden from view behind a thick buffer hedge which includes mature trees

As part of the land's previous management for grazing, tall buffer hedges have been allowed to develop along both banks of much of the river's course, both here and downstream. This has had the significant benefit of protecting the banks from poaching by livestock, as well as allowing strong root structures to develop for bank stability - but it has also had the effect of overshadowing the river and making it very dark and tunnelled in many places.

To allow more light into the river for primary production in the aquatic food web, careful 'skylighting' should be considered: opening gaps in the dense foliage and canopy to create more dappled shade and allow more light into the river corridor. Depending on location, a ratio of 40:60 light:shade is currently considered to be a reasonable target for a productive watercourse where aquatic macrophytes might become established, with proportionately more light over shallow riffled areas, and more shade over deeper pools.

In the course of careful skylighting efforts, individually selected trees could be 'hinged' and secured into the margins of the river as 'large woody material' (LWM), in a process much like aquatic hedge laying. This is designed to imitate natural

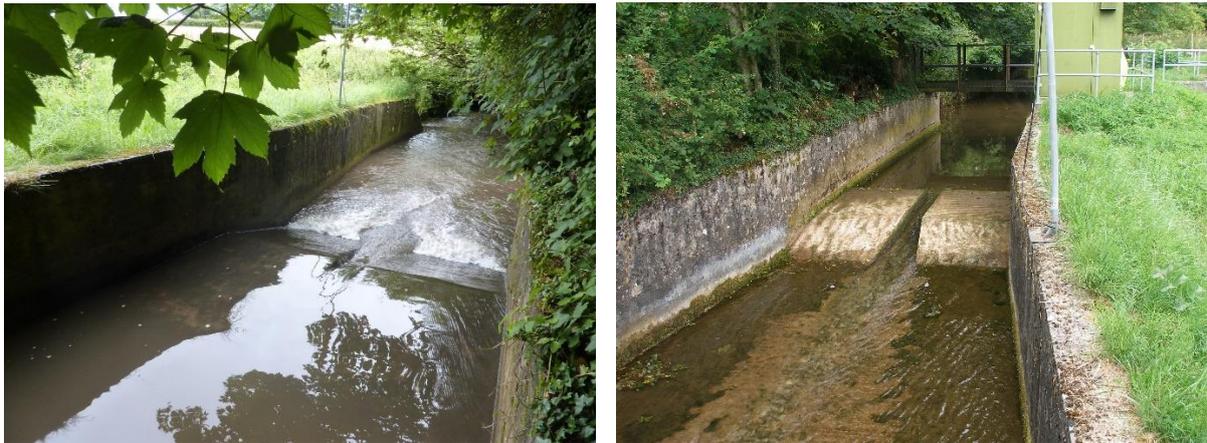
Figure 5: Looking downstream (left) and upstream (right – image courtesy of EA) at the Henley Wookey gauging weir, which is likely to pose a barrier to movement of most fish species under most flow conditions

At ST 52701 45806, approximately halfway down this straightened stretch of river, there is a concrete compound-type weir structure, with an additional back channel on the LB. It is understood that these are owned by Bristol Water, having been constructed in the 1950s to measure flows that allow abstraction further downstream at Brinscombe: the EA and its predecessors have also collected data here since the mid-1990s (pers. comm. EA, August 2024).

As shown in the right-hand image above, the gauging structure is 'a type of flume with a hump in the bed, and a groove cut into the centre which goes down to bed level' (pers. comm. EA, August 2024).

The structure of this weir does not appear to be as extreme as some larger 'flume-type' gauging stations on other Somerset rivers, but given its age, it is unlikely to have been designed with fish passage in mind, and is likely to present a barrier to most fish under most flow conditions. The width of the narrow central notch was presumably calculated to ensure that upstream levels were maintained over a comparatively wild range of flow scenarios: thus, at high flows, water velocity through the central slot may be high and problematic, even for larger fish, while at low flows, lack of depth may limit the size of fish that can use the notch, and the shallow, exposed area downstream may also present a behavioural deterrent.

Overall, some larger fish may be able to pass at medium and low flow conditions, but could struggle at precisely the time when they might be triggered to migrate in higher flows. If maintaining upstream levels is not considered critical, it may be possible to slice away one side of the notch to widen it, thus moderating flow velocities through the notch under conditions when fish are more likely to move. At the same time, it would also be beneficial to roughen the wing wall / spillway interface for improved eel migration.

Meanwhile, the back channel is thought to have been built as an alternative flow pathway, to facilitate dewatering the main channel for maintenance. Although the sluice boards at the upstream end of this back channel are understood to be deteriorating (pers. comm. EA, August 2024), it is also unlikely to have been designed to function as a fish pass.

Overall, seeking to remove this weir completely would certainly be the best solution for the upper River Axe and its ecology, and all possible options should be investigated with Bristol Water and the EA. For example, the artificial nature of both concrete channels at this gauging station, and their fixed cross sections, would almost certainly make the whole site an easy candidate for upgrading to ultrasonic / hydroacoustic flow gauging:

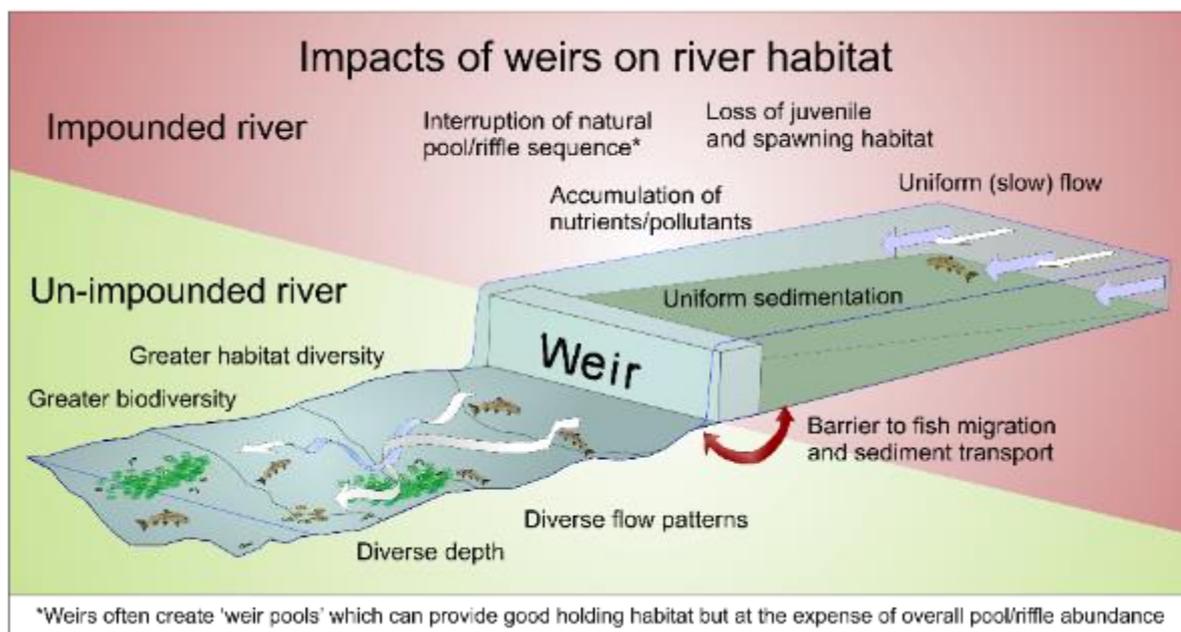
In general terms, whatever the purpose of any individual weir or dam, these structures cause problems for rivers because they impound long stretches of very slowly-moving water, where sediment carried in suspension drops out of the water column uniformly across the stream bed, and habitat quality and diversity are severely degraded. Such conditions can sometimes provide sufficient deep-water habitat for small numbers of adult trout and other species (until the deep water inevitably fills with sediment) but are generally unsuitable for gravel spawning fish, fry and juveniles.

Figure 6: An illustration showing the impacts of weirs on habitat quality

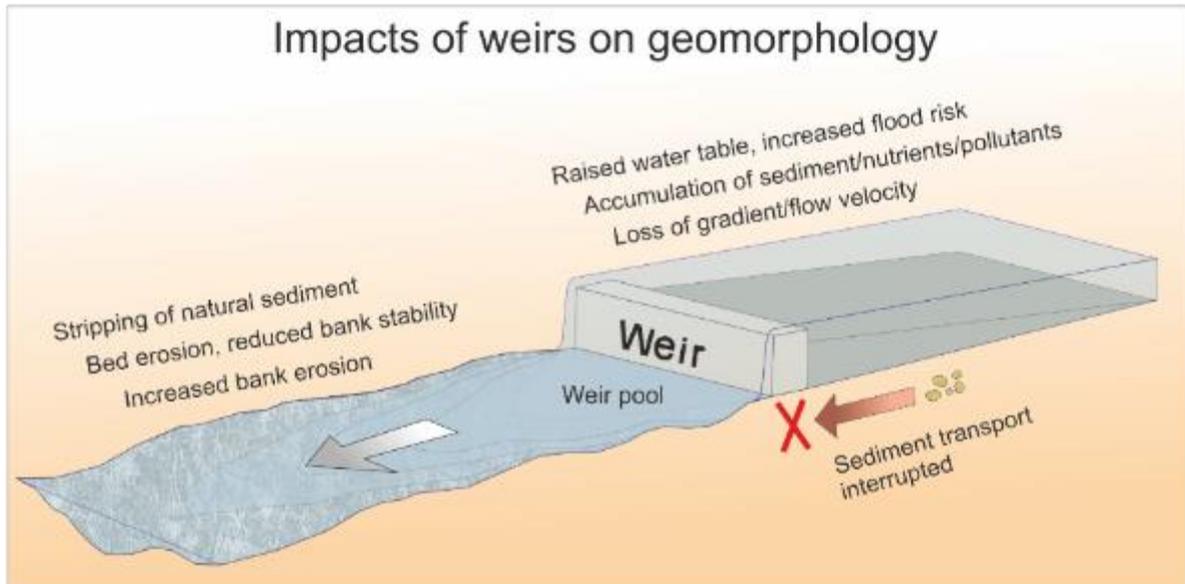
Weirs are often significant barriers – or even complete obstacles – to fish passage, preventing many species from moving up and down rivers freely to fulfil the different stages of their life cycles. Weirs also interrupt the natural transport of river sediment. This can cause the river downstream to become depleted of coarse sediment, and increase rates of bed and bank erosion in an attempt to compensate for the interrupted supply of suitable gravel and cobbles.

Figure 7: An illustration showing the impacts of weirs on river geomorphology

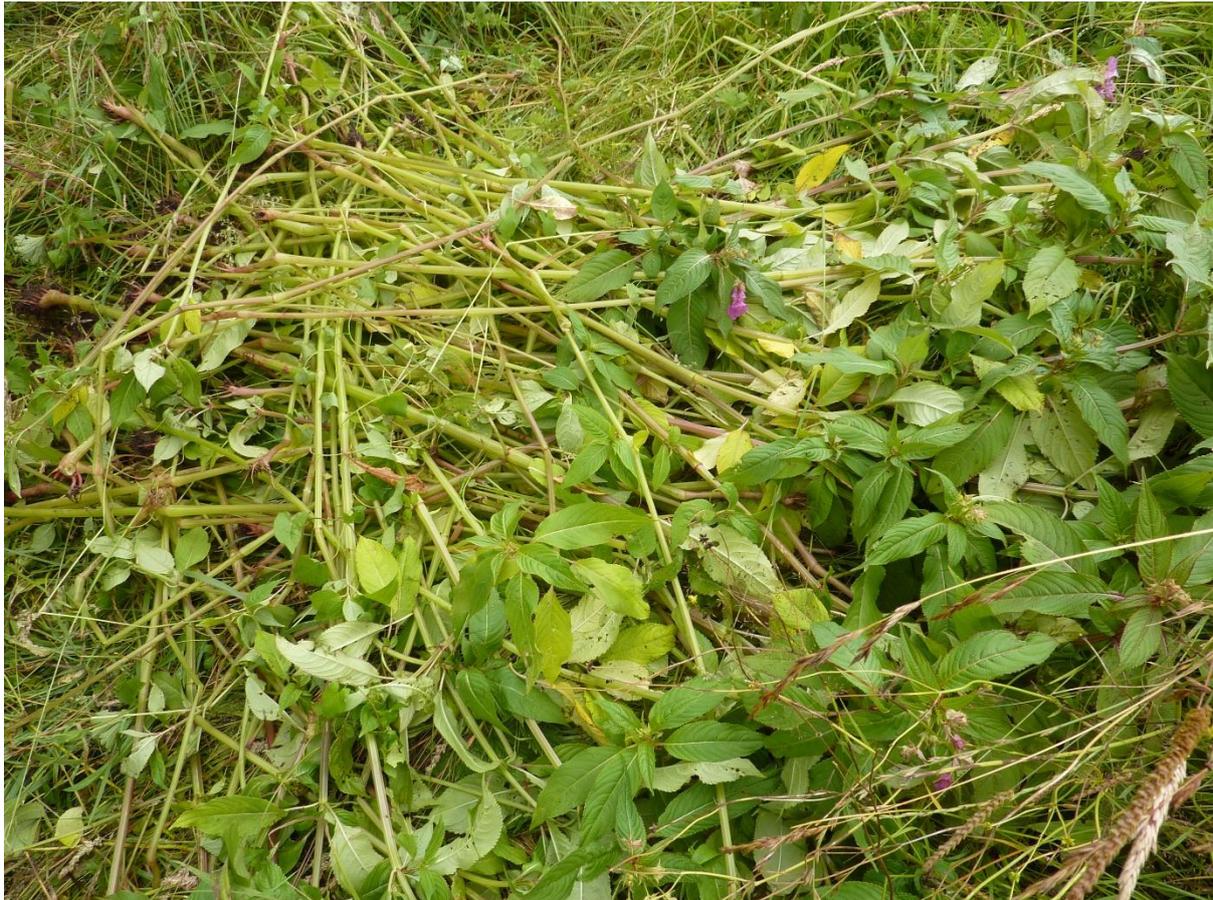
Figure 7: A stand of Himalayan balsam pulled at Kingfisher Common. To help ensure effective clearance, plants should be snapped between the root ball and the lowest node of the stem, to prevent further growth, before being piled up to compost away from the immediate working area and any watercourses

Around NGR ST 52685 45742, it was good to see that the landowner and colleagues have been actively pulling Himalayan balsam (HB). Other HB plants were also noted growing in various areas around Kingfisher Common.

HB is a damaging invasive non-native species: a tall, shallow-rooted plant which spreads with floating, spring-loaded seeds which can be ejected up to 7 metres from the parent plant. It grows in dense monoculture stands that shade out native species before dying back in winter, leaving bare soil without perennial root structure to help resist erosion. Riverbank erosion can contribute significantly to riverbed sedimentation (one recent study suggests a rate of 10 tonnes per km per year) smothering gravels, invertebrates and fish eggs. More generally, HB also reduces biodiversity by suppressing native plants with allelopathic compounds in the soil and attracting insects to pollinate its flowers preferentially with its strong scent and prolific nectar.

Extensive areas of HB monoculture can be brought under control by repeated strimming or mowing, with hand-pulling as a follow-up measure. For smaller areas, or greater selectivity when HB is growing among other more desirable plants, hand-pulling is a tried and tested means of control and eventual eradication, as well as an excellent form of community engagement.

For sustainable long-term results, a catchment-scale approach is required: the furthest upstream extent of the infestation should be located, with a systematic programme of eradication designed to progressively push HB further and further downstream, and eventually out of the catchment completely. In practice, this may need to include investigation of the Priddy Ponds area, the point from which HB is suspected to have spread downstream through the hydrological catchment since the 1970s.

In general, HB seeds appear to survive in the soil for around 3 years, so it may be necessary to revisit previously infested areas for at least this length of time. For best results, areas of infestation should also be revisited repeatedly through the growing season, up to the time of the first frosts in autumn, to prevent late-germinating plants from flowering and setting a seed bank for the next year.

Once pulled or strimmed, HB plants should be piled up to compost well away from any watercourses, with the stems snapped between the root and the first node of the stem to prevent resprouting: the fleshy plants will desiccate quickly, and experience shows that few seeds will survive this process to germinate in future years.

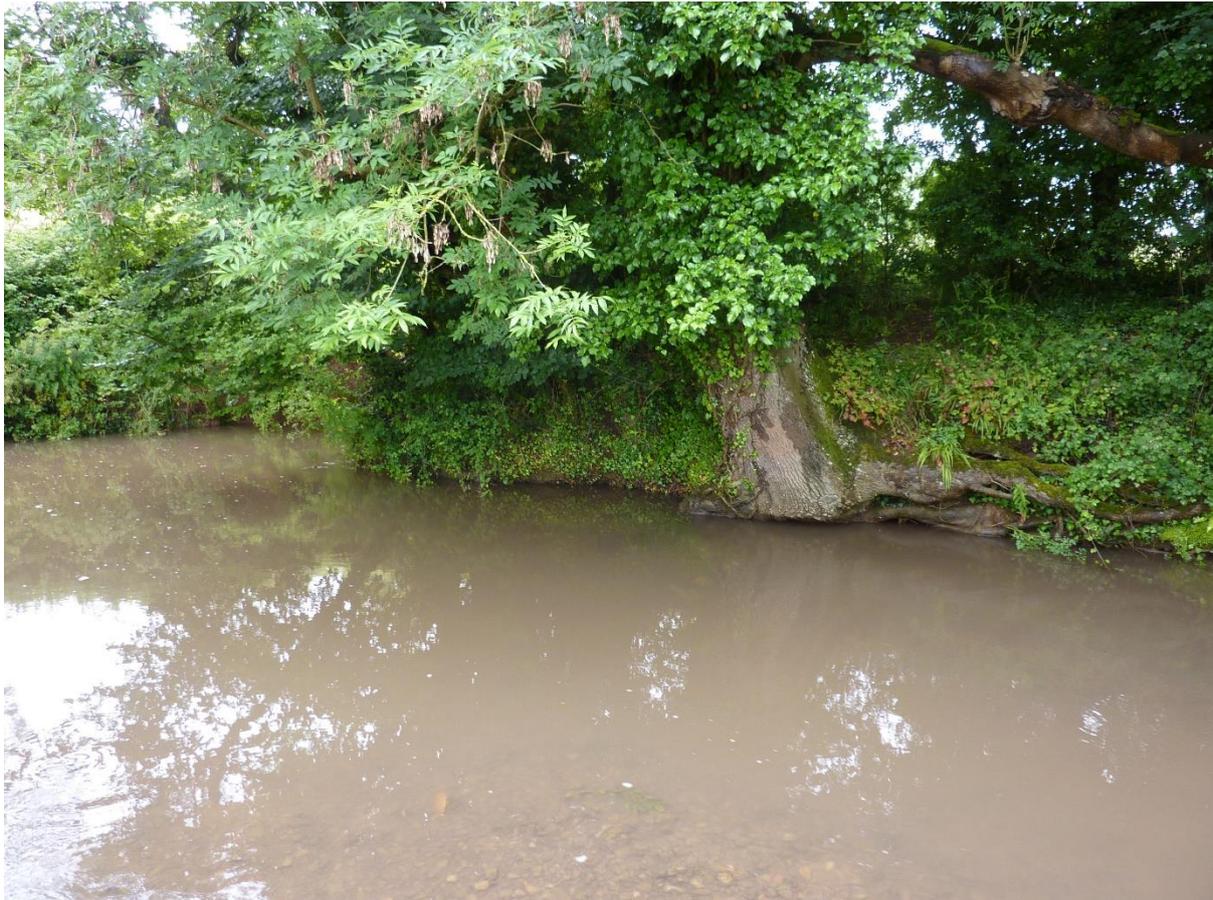
Figure 8: Good adult trout habitat including deep water, undercut banks naturally reinforced with tree roots, and shaggy river margins seen upstream. The turbidity of the water, still at comparatively low flows despite overnight rain, may indicate wider issues of fine sediment ingress into the upper Axe catchment: for example, runoff from roads or ploughed fields

As the River Axe curves round to flow north-west at NGR ST 52623 45707, the overshadowing so prevalent further upstream is reduced, and the narrow river channel runs out into a wider and deeper pool (perhaps a scour hole associated with a previously fallen tree).

Together with 'shaggy' margins provided by overhanging bramble bushes, and an undercut bank supported by the linear root system of a large ash tree, this pool should provide good habitat for adult trout (and indeed a fish was seen to take an insect from the water surface adjacent to the tree roots during this walkover). Rough shaggy river margins, and the diversity of life that they harbour, are extremely important for the health of rivers and their aquatic communities, and every effort should be made to avoid bankside 'tidying' as part of future management regimes at Kingfisher Common.

In due course, it is possible that the ash tree will succumb to ash dieback disease, and may fall into the river. If this happens, it would be very valuable to retain as much LWM as possible within the channel - rather than automatically seeking to remove the whole tree, as standard river management practices might have suggested in the past. (See Appendix B for links to WTT's detailed guidance on LWM structures which use woody material to improve river habitat).

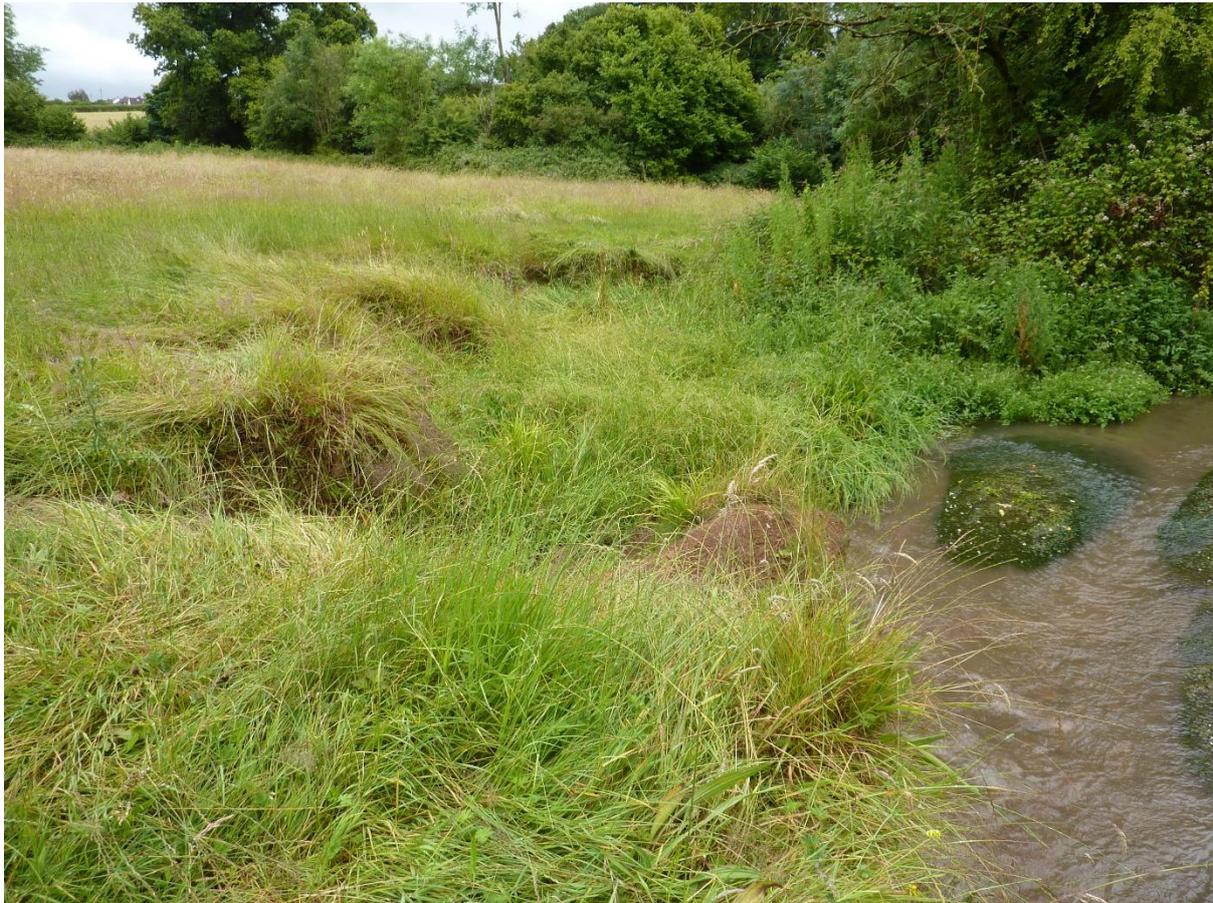
Figure 8: An area of bank which is now re-vegetating well after livestock poaching – preventing further ingress of silt into the river: water crowfoot can also be seen on the gravel riffle

At NGR ST 52580 45743 (also shown on the front cover of this report) downstream of the deep pool, a wide gravel riffle had previously been used as a livestock ford, with significant historic 'poaching' apparent on both banks.

With the abundance of sunlight reaching this unshaded area, strong growths of water crowfoot and watercress were apparent – creating braided channels between stands of vegetation, and potentially even developing a semi-permanent mid-channel island. Areas like these, with such a diversity of habitat types, offer ideal spawning and juvenile habitat for gravel-spawning fish such as trout. Water crowfoot, and the community of invertebrates which live in its complex, fronded structure, also makes a significant contribution to filtering excessive nutrients and other pollution out of the water column. Meanwhile, watercress has an important role in maintaining the depth of flows by pinching the channel when water crowfoot dies back, as part of its annual life cycle, later in the year.

In the time since grazing ceased, significant recovery has taken place on the RB – with grasses, water mint and other riparian species re-growing strongly. The LB, in an erosive area on the outside of the bend, appears to be re-stabilising less rapidly. It is possible that the slower recovery is partly due to dogs accessing the river at this point, creating 'dog slides' which are unable to re-vegetate, and soon

Similar 'dog slide' type bank erosion was also observed on the LB of the offtake to the mill stream at Highovers weir. If possible, dog walkers should be encouraged not to let their pets into the river at either location, perhaps by means of informative signage. If problematic erosion accelerates, the bank toes could be protected with staked and wired LWM, and the faces of the banks could be replanted with plugs of suitably deep-rooted native plants, with defensive dead hedges designed to reduce access on the bank tops above. Alternatively, one or both of these locations could be formalised as a dog dipping areas, with stepped log and gravel 'beaches' to minimise erosion and input of fine sediment.

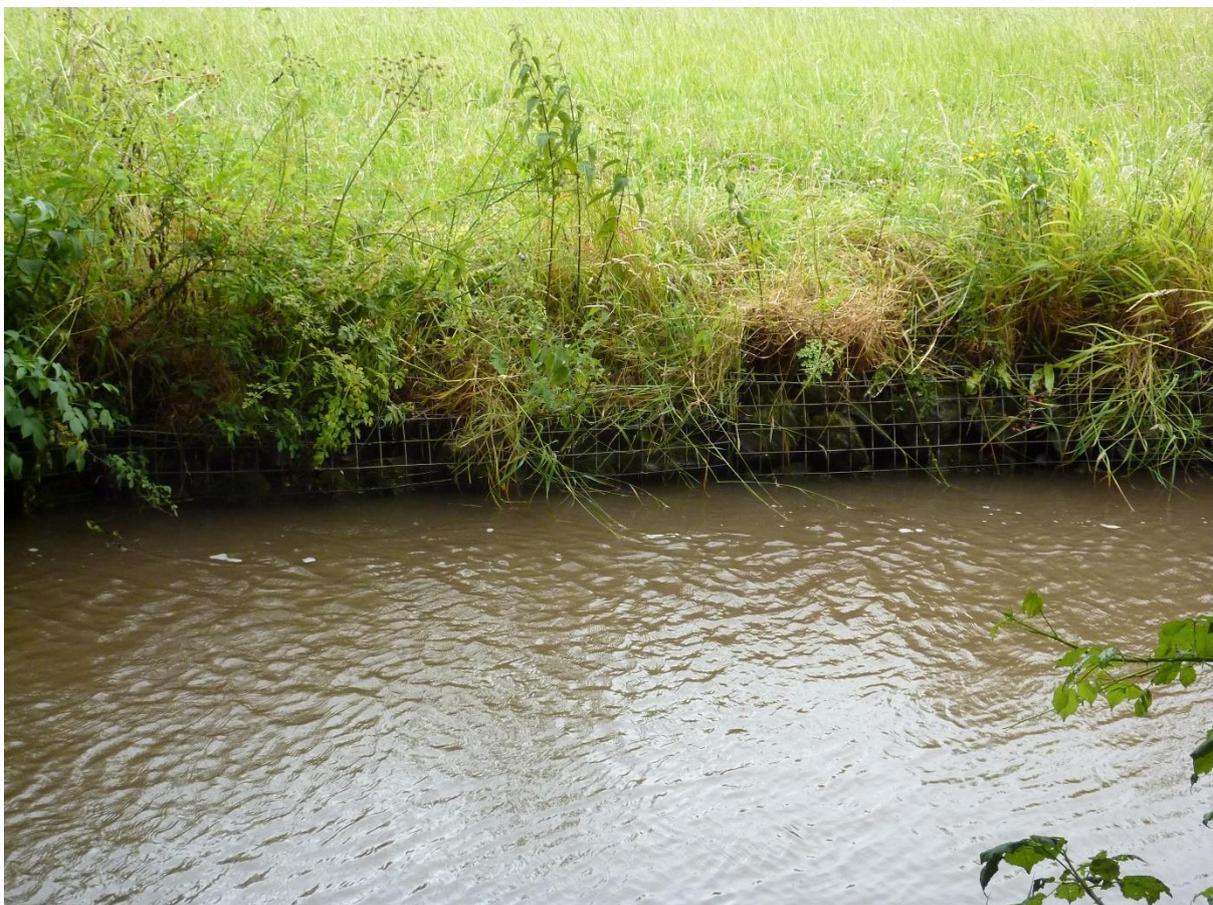
Figure 8: Rock and wire gabion revetments: additional soft, trailing cover (and visual enhancement) could be provided by planting goat willow whips, to be hinged over into the channel in future

At NGR ST 52541 45702, as the river curves towards Highovers weir, the LB is extensively revetted with stone and wire gabion work around the outside of the bend. This may be designed to prevent erosion and subsequent lateral movement of the channel, with consequences for the flow control structure just downstream.

Although the revetment is unnatural, and interrupts the natural processes of erosion which supply the river with gravels and allow it to migrate around its

floodplain, removal may not be feasible for the reasons suggested above. However, some low trailing cover is already present, and it should be possible to further soften flows around this curve by planting willow whips in the bank, with the aim of eventually hinging them into the channel, in a downstream direction, to 'slow the flow' and provide complex, trailing woody habitat for fish, birds and insects. Goat willow or grey willow (sallow) are recommended for this intervention (instead of eg cricket bat willow, which will soon grow over-large and become an ongoing management issue).

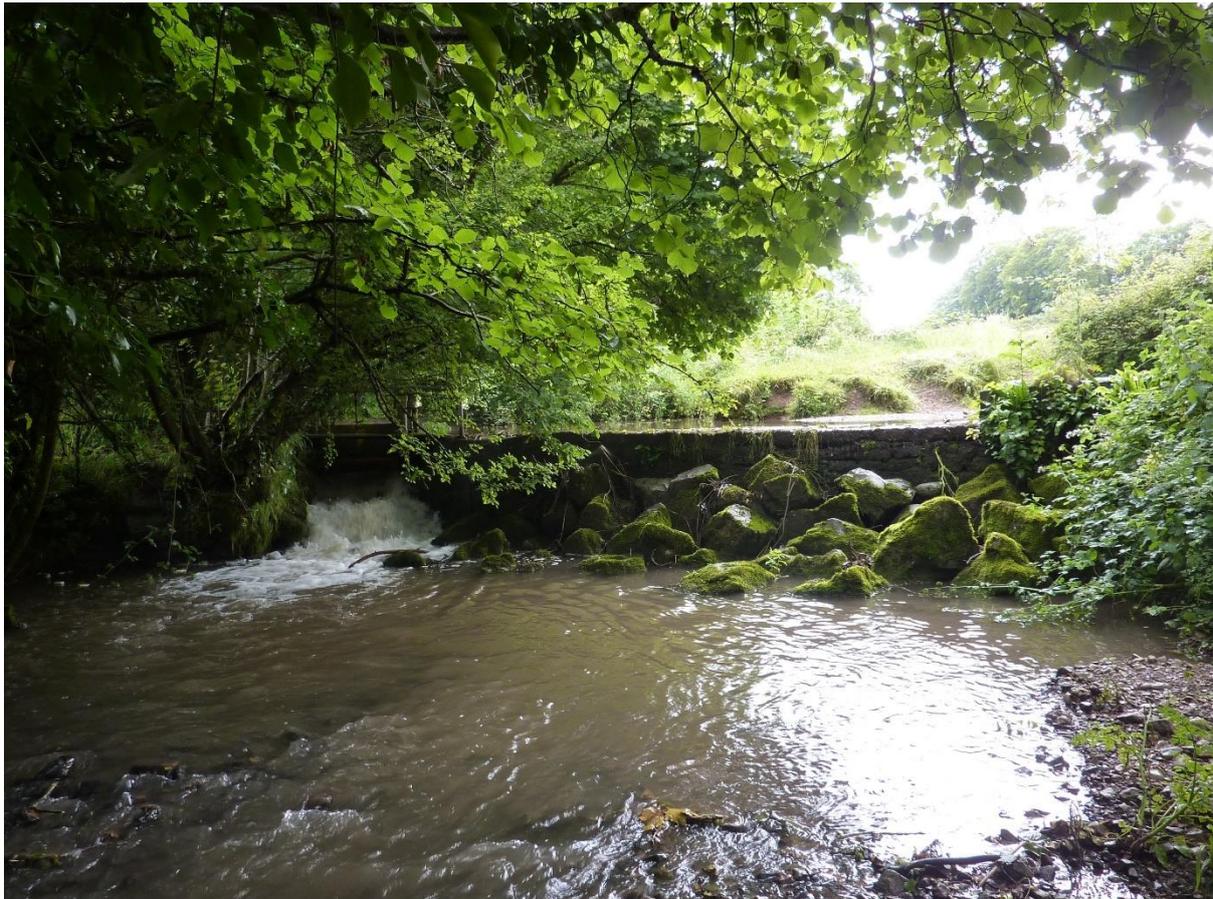
Figure 9: Highovers weir, seen from downstream: a complete barrier to migration for all fish species. Note also the likely 'dog slide' bankside erosion, above the weir at top right of this photo

At NGR ST 52511 45710, Highovers weir occupies the site of a flow control structure which may have been operational since the 10th century (although no listing of any kind can be found on the Somerset Historic Environment Record).

The orientation of the weir shows how flows were historically directed south towards the mill stream, leaving the more natural northern course of the river as a 'relief channel' for excess higher flows. Today, the Highovers weir sluice is controlled by the Environment Agency: it is understood that this sluice is usually closed in winter and opened in summer to balance flows down each course of the river, but there are no specific target flows for either channel (pers. comm EA, August 2024).

Additionally, approximately every 4-5 years, or when sediment accumulation above Highovers weir threatens to constrict flows into the mill stream channel, the EA conducts gravel clearing operations in this area. These gravels are deposited in the main river channel immediately downstream of the weir, to ensure continuation of sediment transport processes. At the time of writing this report, the next gravel clearance is scheduled to take place in week commencing 12 August 2024 (pers. comm. EA, August 2024).

Despite the intermittent nature of such formalised gravel replenishment downstream of the weir, and the time elapsed since the EA's previous clearance operation, it is interesting to note that the mix of cobbles, gravels and finer sediments did not seem unduly depleted at the time of this Advisory Visit. This may suggest that high flows in the Axe are energetic enough to carry sediment over the structure (or through the sluice gate) in sufficient quantity to maintain some sediment transport – and / or that the upstream pool has reached an equilibrium by infilling (which will shortly be interrupted again by gravel clearing operations), thus enabling a sporadic sediment supply over the weir at high flows.

Although the large boulders dumped below the vertical face of the weir might conceivably provide enough turbulence for salmonid fish to surmount it at the very highest flows, to all intents and purposes the sluice and the current weir structure are a total barrier to fish of all species. As such, for the reasons described above, it would be very beneficial to investigate enhancing fish passage at this weir, for all species of fish including eels.

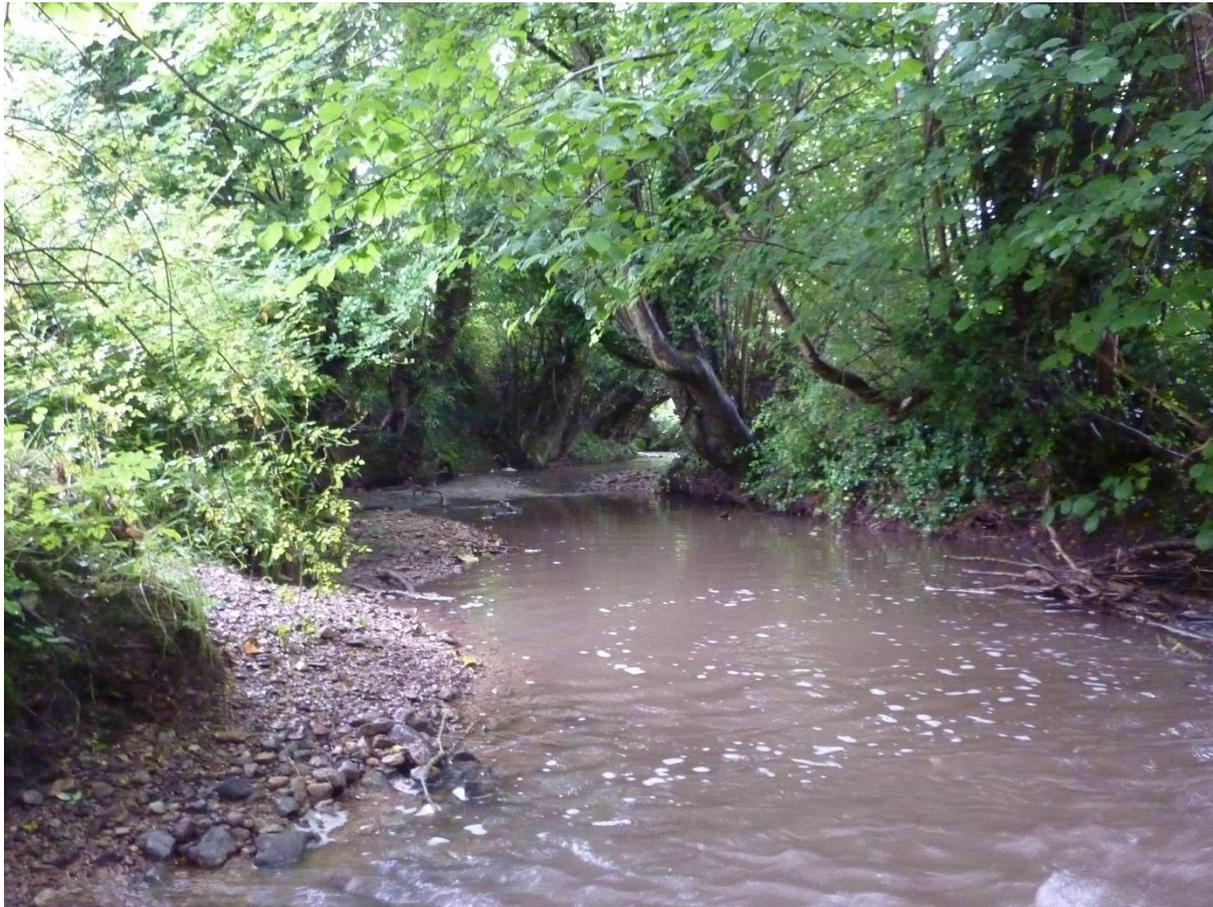
Figure 10: The main River Axe downstream of Highovers weir

Further downstream of Highovers weir, between NGRs ST 52511 45710 and ST 52262 45643, the channel of the River Axe displays a naturally meandering plan form with pools, riffles and very abundant gravels. As previously noted upstream, the river is heavily shaded by the height and thickness of the mature hedges on the bank tops, but there should be abundant opportunities for selective skylighting (which could be identified via a future walkthrough of the channel in low water).

As above, see Appendix B for links to WTT's detailed guidance on LWM structures which use woody material to improve river habitat.

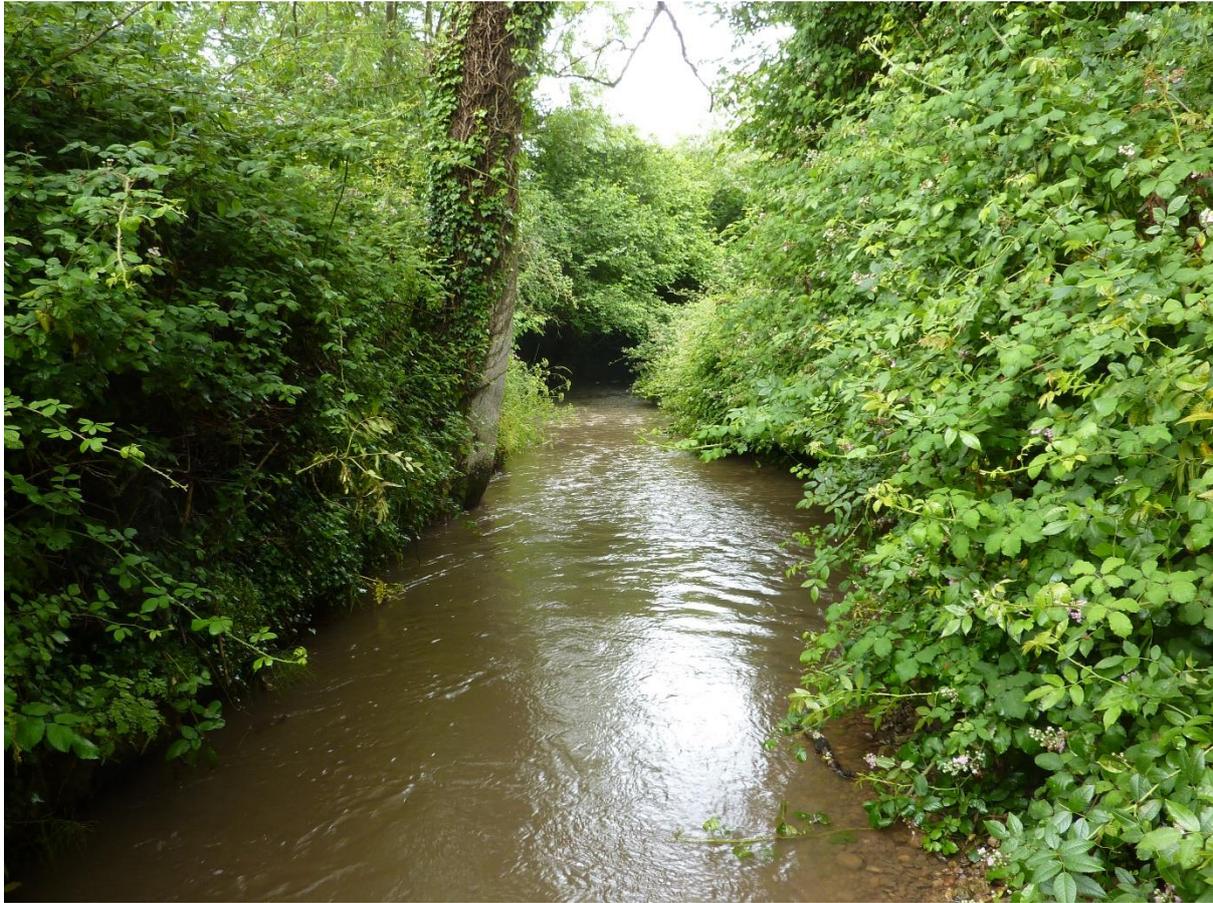
Figure 11: The mill stream, looking downstream from Highovers weir: compare the straightness and uniformity of this channel with the much more naturalistic and dynamic channel shown in Figure 10

Downstream of the diversion structure at Highovers weir, the engineered mill stream channel between NGRs ST 52513 45705 and ST 52330 45631 is characteristically uniform, straight and incised (although almost immediately perched above the level of the northern river channel) - having been designed to deliver a high and steady flow of water to the mill villages of Worth, Yarley, Henton and Bleadney.

As seen upstream at Kingfisher Common, the banks have been protected from livestock poaching by thick hedges. In the less heavily shaded reaches, stands of water crowfoot have become established, and at least one naturally skylighted area was noted where a large tree had fallen (perhaps as a result of ash dieback disease).

As described above, selected bankside trees could be hinged into the margins of the channel, while naturally fallen LWM should be left in place if possible, or (if

absolutely necessary) winched and staked parallel to the bank. More formal flow deflectors could also be installed in suitable locations to kick-start scour and deposition: skylighting will also help water crowfoot and other emergent vegetation to perform a similar function. All these interventions should help to mitigate the unnaturally uniform shape of the channel (which may also have been maintained in the past by dredging).

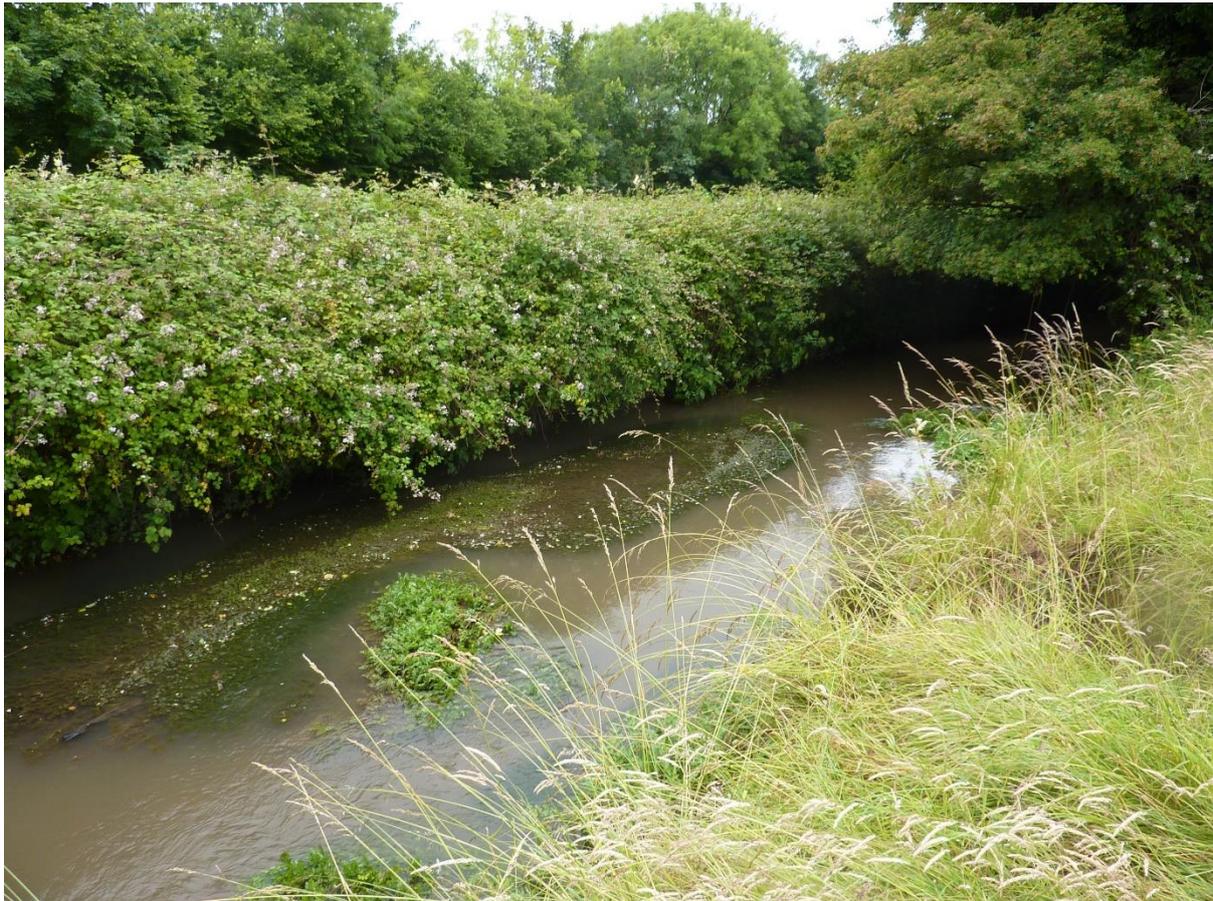
At the downstream end of this stretch, the mill stream flows out of Kingfisher Common under the B3139 road bridge towards Burcott Mill: however, at the time of the visit, no impoundment effect from the mill was observed this far upstream.

Figure 12: The mill stream as it approaches the lower boundary of Kingfisher Common. Note how plants like water crowfoot and water cress have established themselves in this 'skylighted' area, helping to mitigate the otherwise uniform profile of the channel

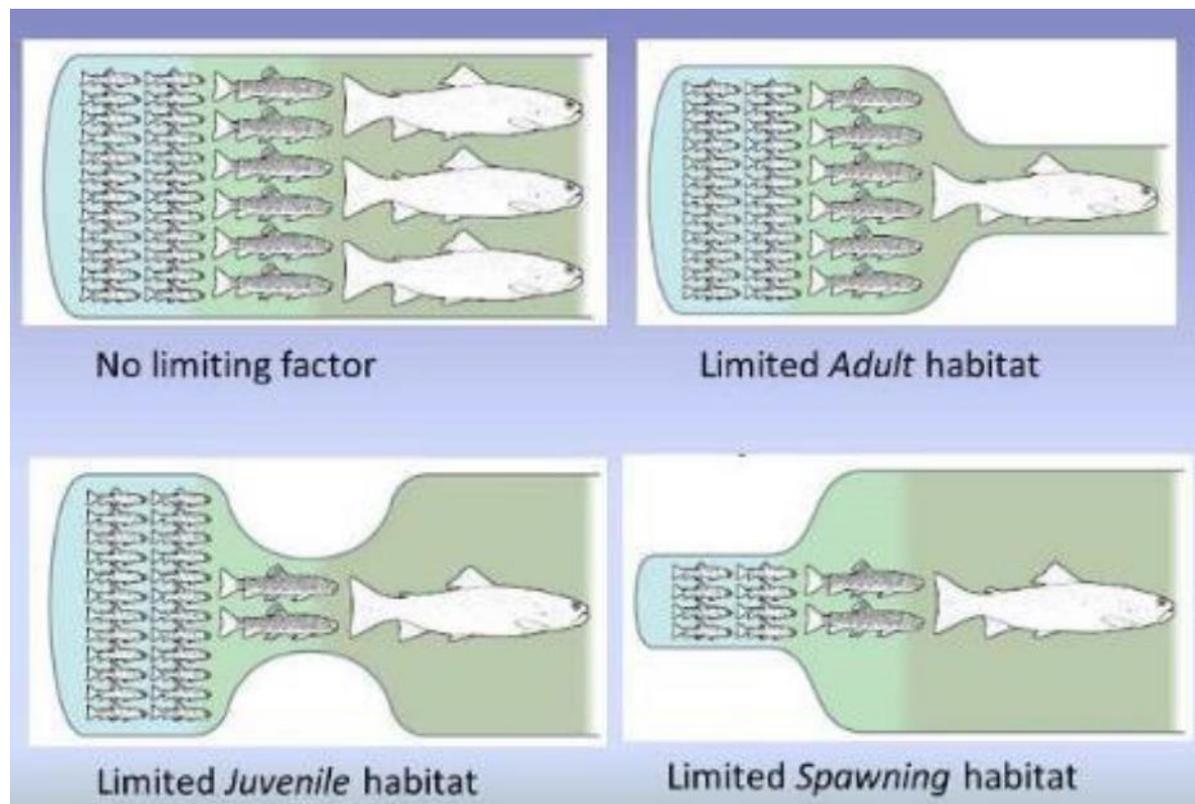
Figure 2: The impacts on trout populations lacking adequate habitat for key life cycle stages. Spawning trout require loose gravel with a good flow-through of oxygenated water. Juvenile trout need shallow water with plenty of diverse structure for protection against predators and wash-out during spates. Adult trout need deeper pools (usually > 30cm depth) with nearby structural cover such as undercut boulders, sunken trees/tree limbs and/or low overhanging cover (ideally trailing on, or at least within 30cm of, the water's surface). Excellent quality in one or two out of the three crucial habitats may not mitigate a 'weak link' in the remaining critical habitat.

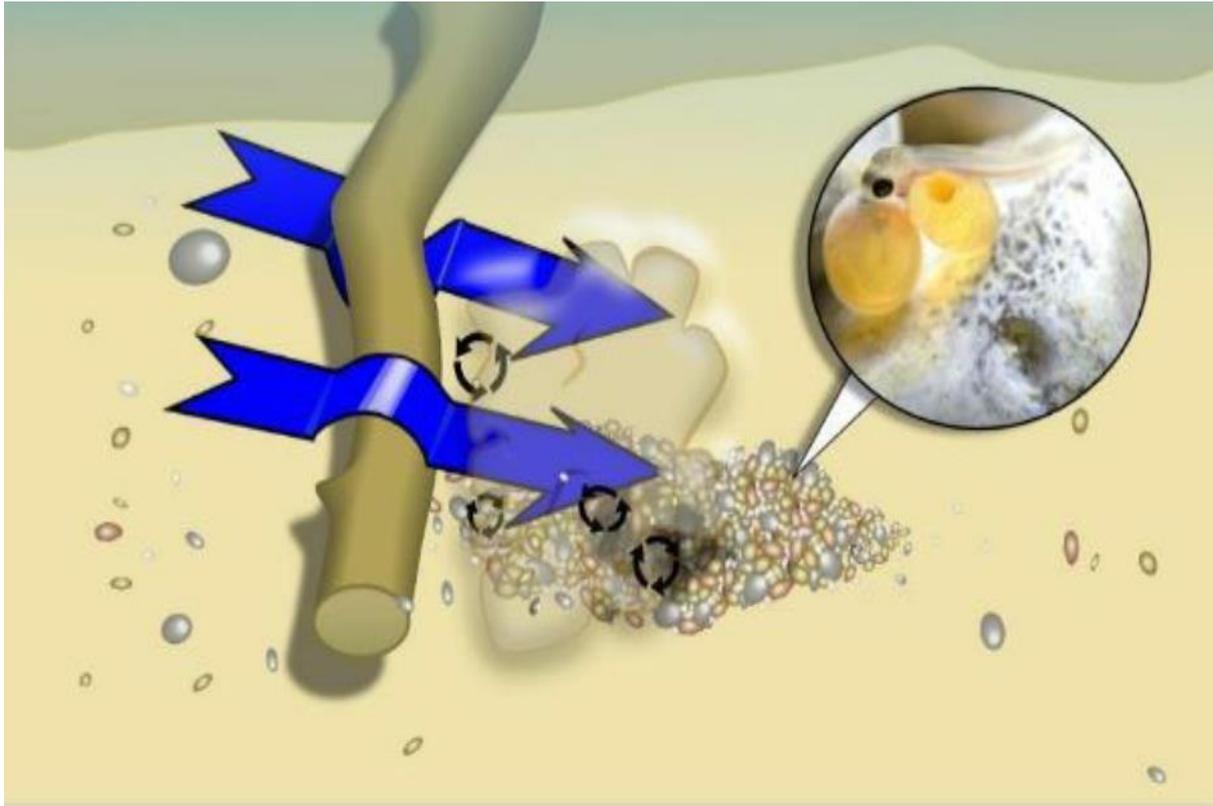
Figure 3: Successful trout spawning habitat requires relatively silt-free gravels. Here, the action of a fallen tree limb is focusing the flows (both under and over the limb as indicated by the blue arrows) on a small area of riverbed that results in silt being washed out from between gravel grains. A small mound of gravel is deposited just below the hollow scoured out by focused flows: this mound will be selected by trout to dig a 'redd' for spawning. In the silt-free gaps between the grains of gravel it is possible for sufficient oxygen-rich water to flow over the developing eggs and newly-hatched 'alevins' to keep them alive as they hide within the gravel mound (inset) until emerging in spring.

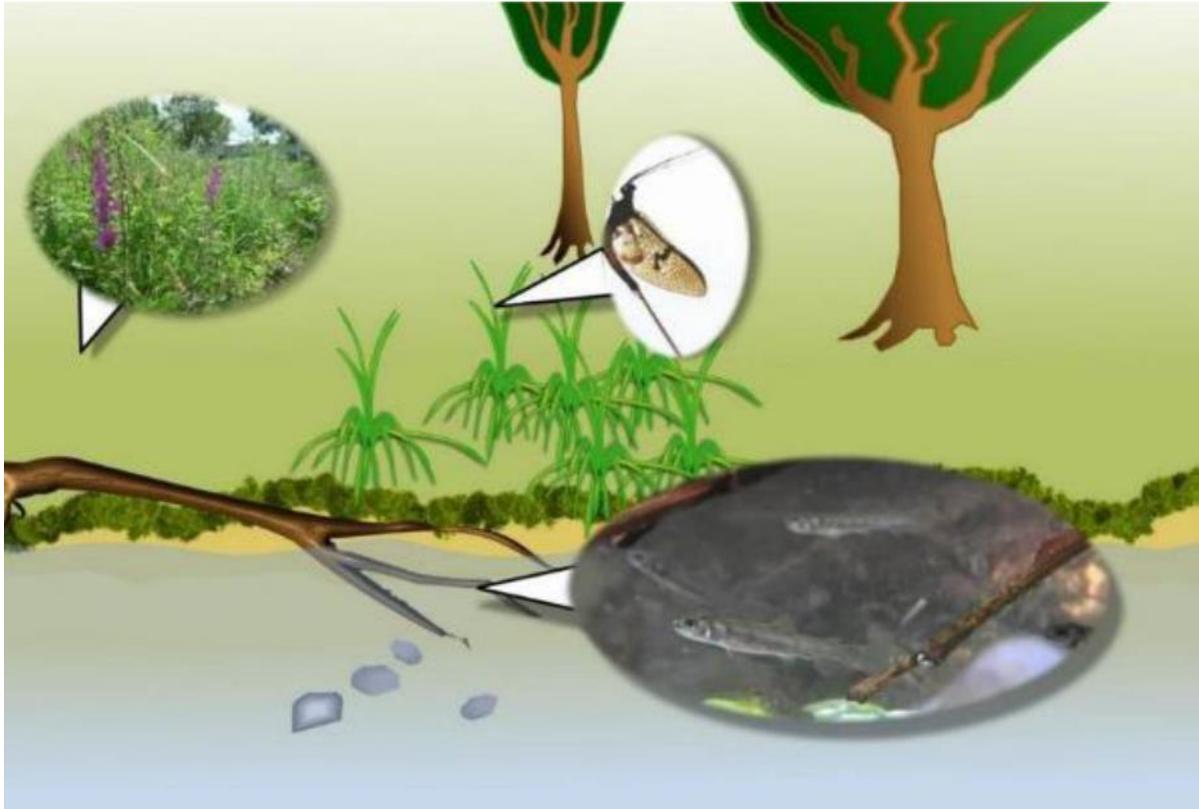
Figure 4: Larger cobbles and submerged 'brashy' cover and/or exposed fronds of tree roots provide vital cover from predation and spate flows for tiny juvenile fish in shallower water (<30cm deep). Trailing, overhanging vegetation also provides a similar function, and has many benefits for invertebrate populations (some of which will provide a ready food supply for the juvenile fish).
