WILD TROUT TRUST
wildtrout.org

River Axe, Kingfisher Common near Wookey, Somerset

Advisory Visit July 2024

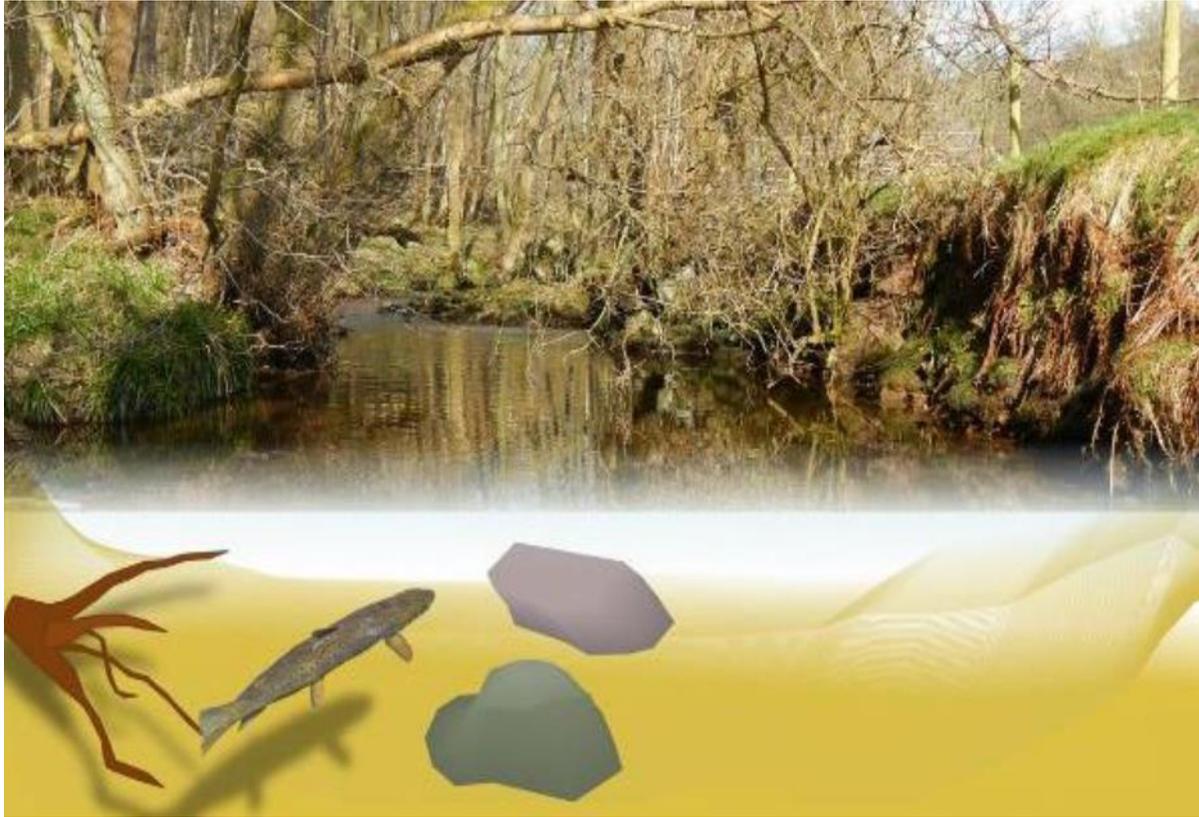
Figure 5: The availability of deeper water bolt holes (>30cm), low overhanging cover and/or larger submerged structures such as boulders, fallen trees, large root-wads etc. close to a good food supply (e.g. below a riffle in this case) are all strong components of adult trout habitat requirements.
